# Differential movements and stresses in high-rise masonry veneers: Case study

G. A. FENTON AND G. T. SUTER

This paper deals with a case study of brick masonry veneer distress on a reinforced concrete high-rise structure. The key cause of distress was the absence of a movement joint at the underside of the shelf angle at each floor level. A computer model introduced by the authors in a previous analysis paper is used to investigate the effects of various parameters on differential movements and veneer stresses. The results indicate that the provision of movement joints of at least 3–4 mm/storey would have prevented a buildup of significant veneer stress. In the absence of a movement joint, veneer stresses were found to be high enough to result in distress as observed on the case study structure. The paper concludes with a discussion of repair considerations.

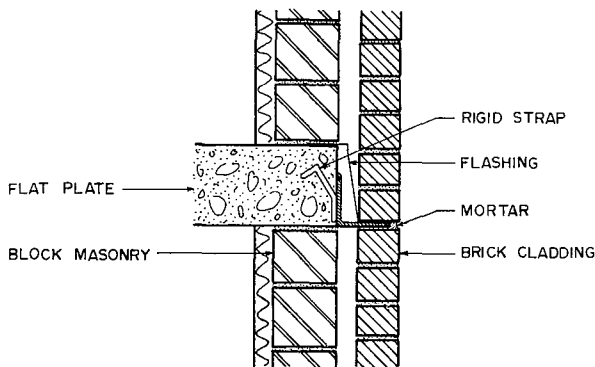
FIG. 2. Typical shelf angle connection on case study structure.

The shelf angle detail used on the structure is shown in Fig. 2. The shelf angle connection to the structure was made by means of a rigid strap cast-in-place at the time of the slab pour. No movement joint was provided at the shelf angle detail. This meant the brick masonry was built tight to the underside of the angle and mortar was placed at the angle's toe. Such a detail was common in the early 1970's. Note that the concrete block masonry was also built tight to the underside of the slab and hence no differential movement capability whatever was built into the structure.

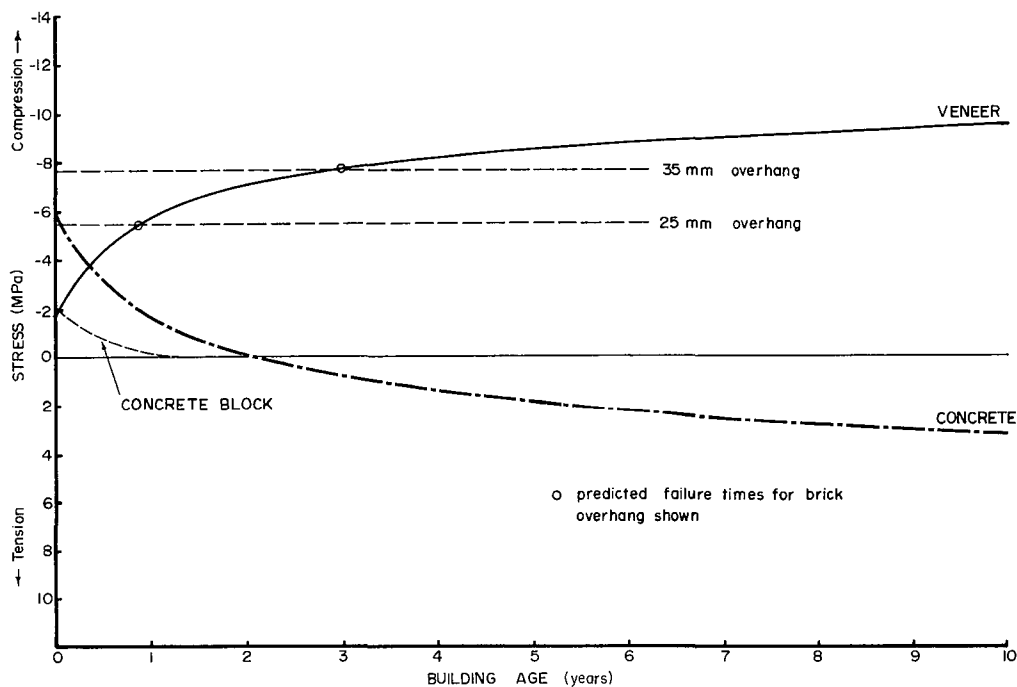
FIG. 3. Ground level veneer, concrete block, and concrete stresses under moderate conditions.

Veneer, concrete block masonry, and concrete stresses have been plotted against time in Fig. 3 for moderate conditions and in Fig. 4 for severe conditions. From these plots some immediate observations can be made:

- (1) Within 1 year, compressive stresses in the veneer are seen to be already 60–65% of their 10-year values.
- (2) Expansion of the veneer combined with contraction of the structure and concrete masonry soon results in the slab lifting off the concrete block masonry, reducing its stress to zero within 3 years.

- (3) As the compressive stress in the veneer increases, the column concrete stress reduces, becoming tensile very rapidly.

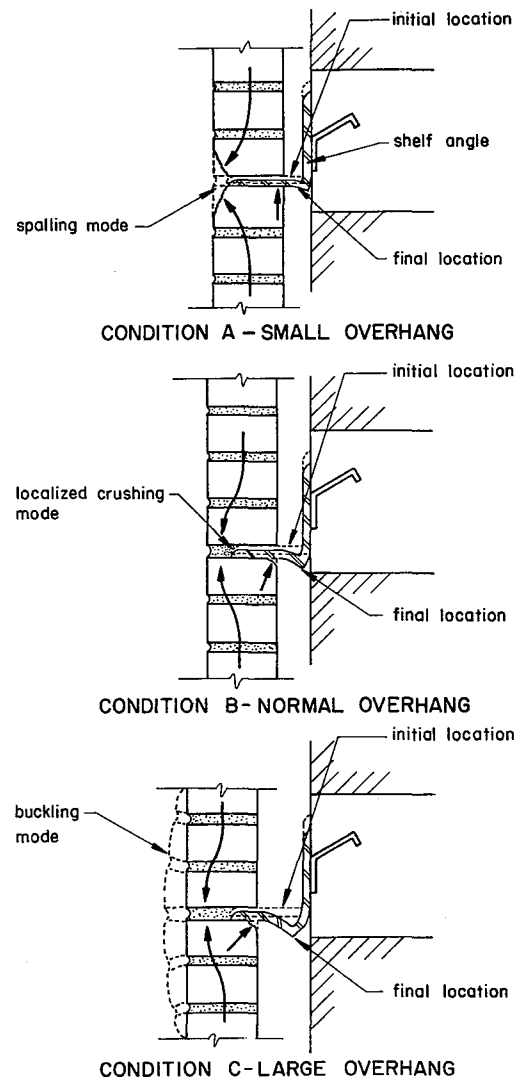
FIG. 5. Veneer failure conditions (shelf angle deformations exaggerated).

in brick overhang can lead to three distinct modes of veneer failure or distress. These modes, along with their corresponding brick overhangs, are illustrated in Fig. 5. For the small brick overhangs of condition A, loads from above are supported by a narrow mortar joint, which concentrates the stress at the face of the brick and may result in spalling. For example, if the mortar is provided over one-quarter the brick width, then the local stress will be four times the average masonry stress. Based on a masonry compressive strength of 20 MPa, the point at which the average predicted veneer stress, combined with this stress concentration factor, is sufficient to cause failure has been shown in Figs. 3 and 4 for two different overhangs. Note that spalling of the brick surface, given a 25 mm overhang, is likely to occur in under 1 year for moderate conditions and in 4 months for severe conditions.

When the brick overhang is very wide, as shown by condition C in Fig. 5, the shelf angle is less restrained against rotation as it deforms, particularly if improper or excessive shimming is used. This rotation can lead to:

Condition B in Fig. 5 shows what is considered to be a normal overhang. High veneer loads may result in crushing of the mortar in the joint but the stress concentration is insufficient to cause spalling or cracking of the brick. Once the mortar has crushed, the joint begins to act as a movement joint, allowing stress relief to take place.

Of the three failure modes, condition C, or the wide overhang, is the least safe, as it can result in a buckling or bulging failure with little or no warning. Conditions A and B are stable, with condition B giving the least visible distress.
