# Differential movements and stresses in high-rise masonry veneers: Case study

G. A. FENTON AND G. T. SUTER

This paper deals with a case study of brick masonry veneer distress on a reinforced concrete high-rise structure. The key cause of distress was the absence of a movement joint at the underside of the shelf angle at each floor level. A computer model introduced by the authors in a previous analysis paper is used to investigate the effects of various parameters on differential movements and veneer stresses. The results indicate that the provision of movement joints of at least 3–4 mm/storey would have prevented a buildup of significant veneer stress. In the absence of a movement joint, veneer stresses were found to be high enough to result in distress as observed on the case study structure. The paper concludes with a discussion of repair considerations.

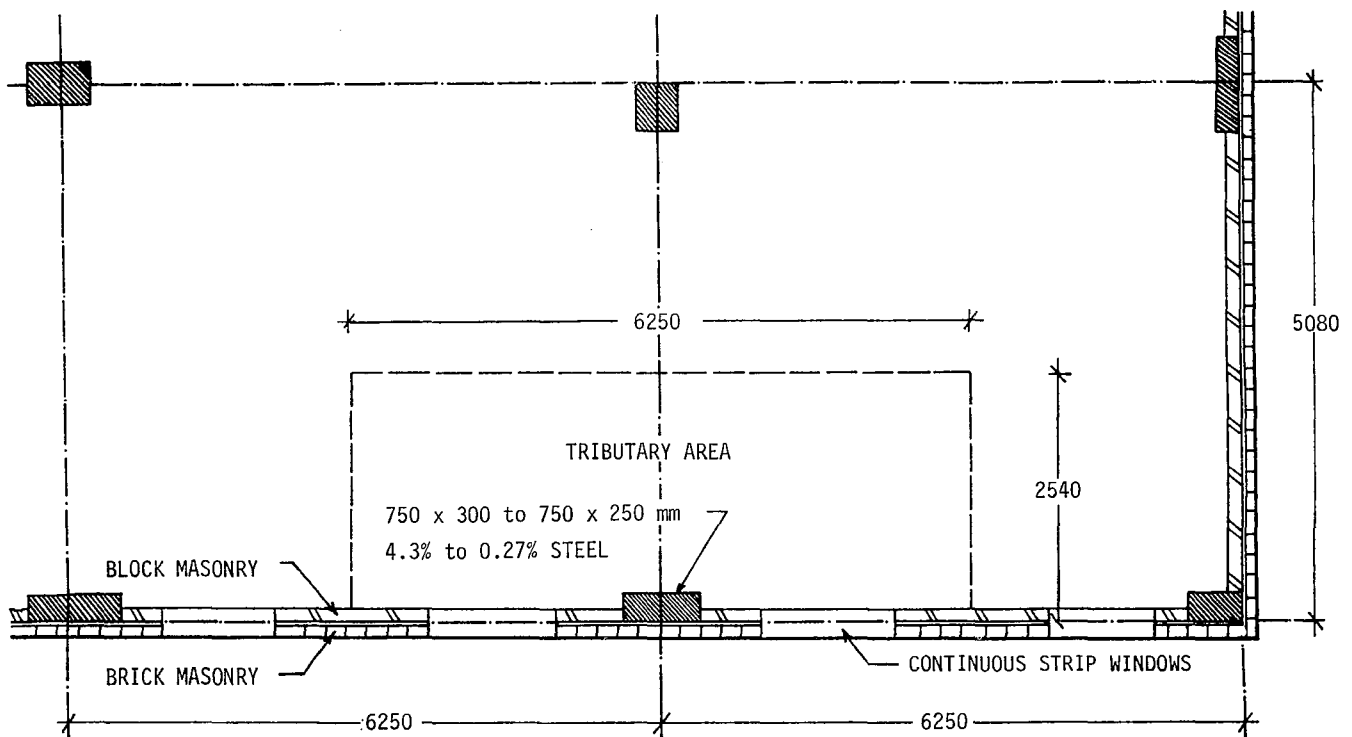
Construction of an 18-storey reinforced concrete flat plate and column apartment building was started in the summer of 1972. The building was clad with 92 mm thick clay brick masonry veneer panels, which were supported at each level on steel shelf angles and which ran in continuous vertical strips from the ground floor to the roof. The veneer was tied to a 140 mm concrete block masonry backup; 25 mm of rigid insulation and 12 mm of drywall placed on the interior face completed the wall assembly. A portion of the typical floor plan is shown in Fig. 1.

FIG. 1. Typical floor plan showing column tributary area.

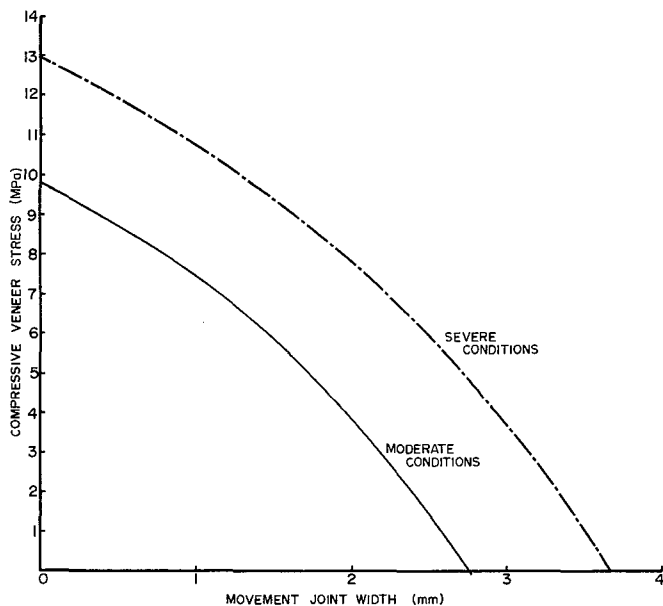
FIG. 6. Effect of movement joint width on ground level veneer stress.

As indicated earlier, there are many design considerations that can influence the magnitude of the load inadvertently transferred from the structure to the veneer. Perhaps the most important of these is the width of the soft joint provided under each shelf angle to accommodate differential movements. Figure 6 shows how the ground level veneer stress on the case study structure after 10 years is affected by changes in the width of the movement joint under all the overlying shelf angles. For the case study structure, it can be seen that the minimum joint width required to eliminate all stress from the veneer is about 3 mm/storey under moderate conditions and 4 mm/storey under severe conditions.

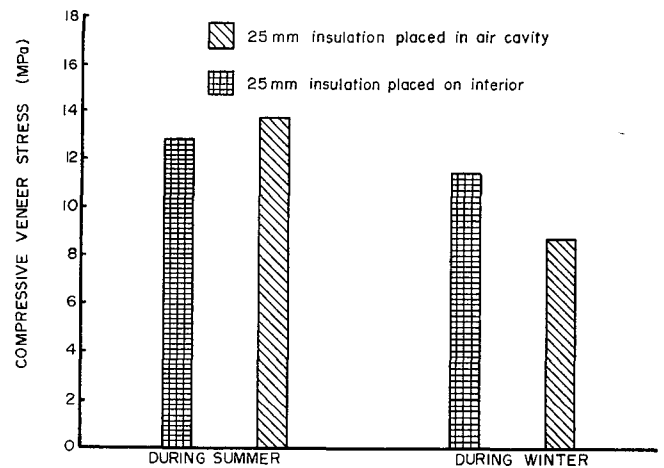
FIG. 7. Effect of insulation location on summer and winter veneer stresses under severe conditions.

Additional trial runs were carried out on the case study building with the insulation placed in the air cavity between the veneer and the structure, to evaluate the effect of insulation location on the stresses developed in the veneer. In the actual structure the insulation was placed on the interior face of the column and concrete masonry. Figure 7 shows how the veneer stresses vary during both the summer and winter after 10 years under severe conditions. From Fig. 7 it can be seen that stresses during the summer are only marginally affected by insulation location. This is so because the thermally massive concrete and concrete masonry elements are not greatly affected by the daily temperature swings of the veneer—even if the insulation is absent.

However, during a cold spell in the depth of winter, the thermal mass of the concrete becomes unimportant and steady state conditions are approached. Thus, placing the insulation between the veneer and the structure rather than on the interior will decrease the veneer stresses by about 30%. In either case,

though, the summer stresses are greater than the winter stresses and so the insulation location will only have a small effect on the maximum annual veneer stress.

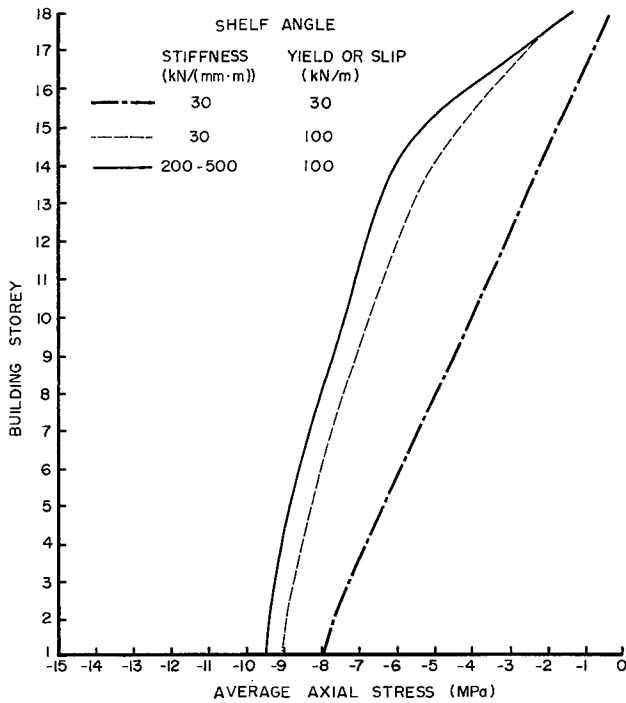
FIG. 8. Variation of veneer stress with height after 10 years under moderate conditions.

If, however, soft joints have not been provided and a sufficient number of shelf angles act above a given level, veneer stress has been found to be largely independent of the shelf angle stiffness and yield point. Figure 8 shows the veneer stress

versus height on the case study building for three different shelf angle stiffnesses. For a constant yield or slip point, the ground level veneer stress changes by only 5% for stiffnesses ranging from 30 to 500 kN/mm per metre length of shelf angle. When the yield point is reduced from 100 to 30 kN/m (of length of shelf angle), the ground level stress is reduced more substantially — by about 15%. The shelf angles used in the case study building, with their relatively rigid welded connections, were calculated to have a stiffness of about 300 kN/mm per metre length of shelf angle.

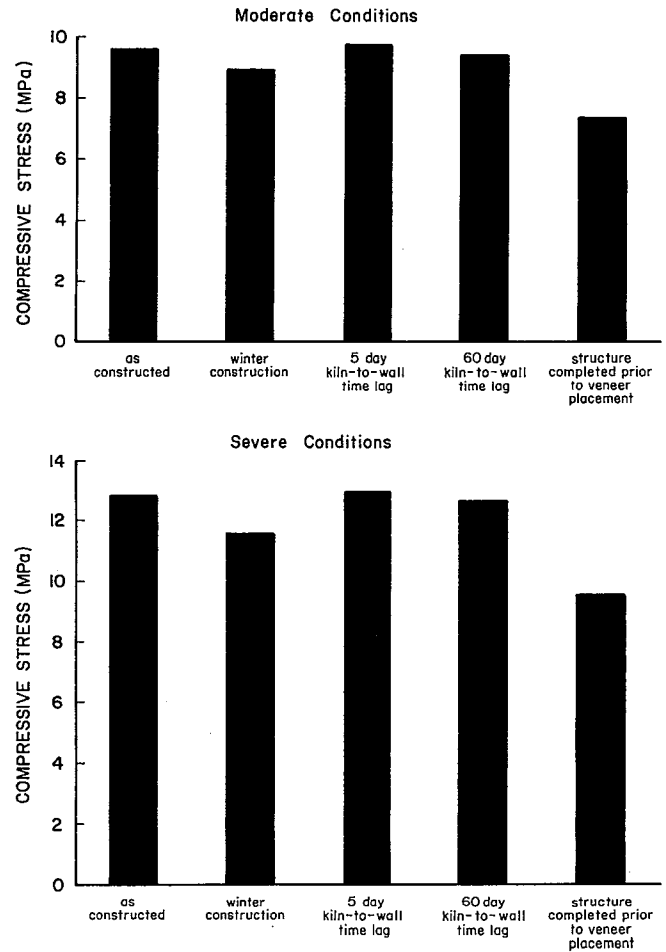
FIG. 9. Predicted ground level veneer stress after 10 years for various construction timing.

The times at which the various structural elements are placed can affect the magnitude of differential movements and resulting stresses. Figure 9 shows graphically the expected ground level veneer stress on the case study building after 10 years for the following timing conditions:

- (1) As constructed.
- (2) Winter construction — construction beginning on November 1 rather than July 1.
- (3) 5-day and 60-day lag between kiln firing of the brick and veneer construction, rather than about 30 days as constructed.
- (4) Placement of the veneer after completion of the entire supporting structure, rather than the 5-level lag as constructed.

Winter construction results in larger thermal strains in both the structure and the veneer. Because the coefficient of thermal expansion of the reinforced concrete is some 25% greater than

that of the veneer, the column undergoes slightly larger thermal strains than the veneer. Thus the veneer stress is seen to be reduced by 7–12% when construction takes place during the winter. Note that if the insulation was placed in the air cavity between the veneer and the structure, the additional thermal strain of the column would be less than that of the veneer and veneer stresses would increase for winter construction.

As the time lag between production of brick units and construction of veneer increases, a greater proportion of the brick moisture expansion takes place prior to installation. Figure 9 shows that when the kiln-to-wall time is increased from 5 to 60 days, the expected veneer stress decreases by only about 2%. Although the corresponding decrease in the moisture expansion strain of the clay brick masonry is closer to 20%, it is only one contributing factor to differential movement.

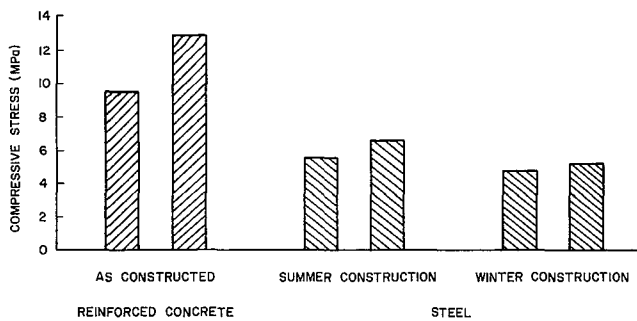
FIG. 10. Predicted ground level veneer stress after 10 years for two structure types.

The previous discussion has concerned itself with differential movements occurring between a reinforced concrete structure and its veneer. Steel structures also commonly employ shelf angles or shelf plates at regular intervals to support the veneer and so it is of interest to compare the two structure types. The predicted ground level veneer stresses depicted in Fig. 10 have been derived assuming the case study building to be a steel structure with dead loads and other parameters held constant. Movement of the structure is now due to elastic and thermal effects only. It can be seen that the absence of creep and shrinkage of the column reduces the veneer stresses by at least 50%. In addition, the dead loads acting in steel structures are usually less than those in reinforced concrete structures, which would further reduce the magnitude of the load transferred to the veneer when inadequate movement joints are present.
